NASA CR-168036
R82AEB399

ENERGY EFFICIENT ENGINE

HIGH PRESSURE TURBINE CERAMIC SHROUD SUPPORT TECHNOLOGY REPORT

November 1982

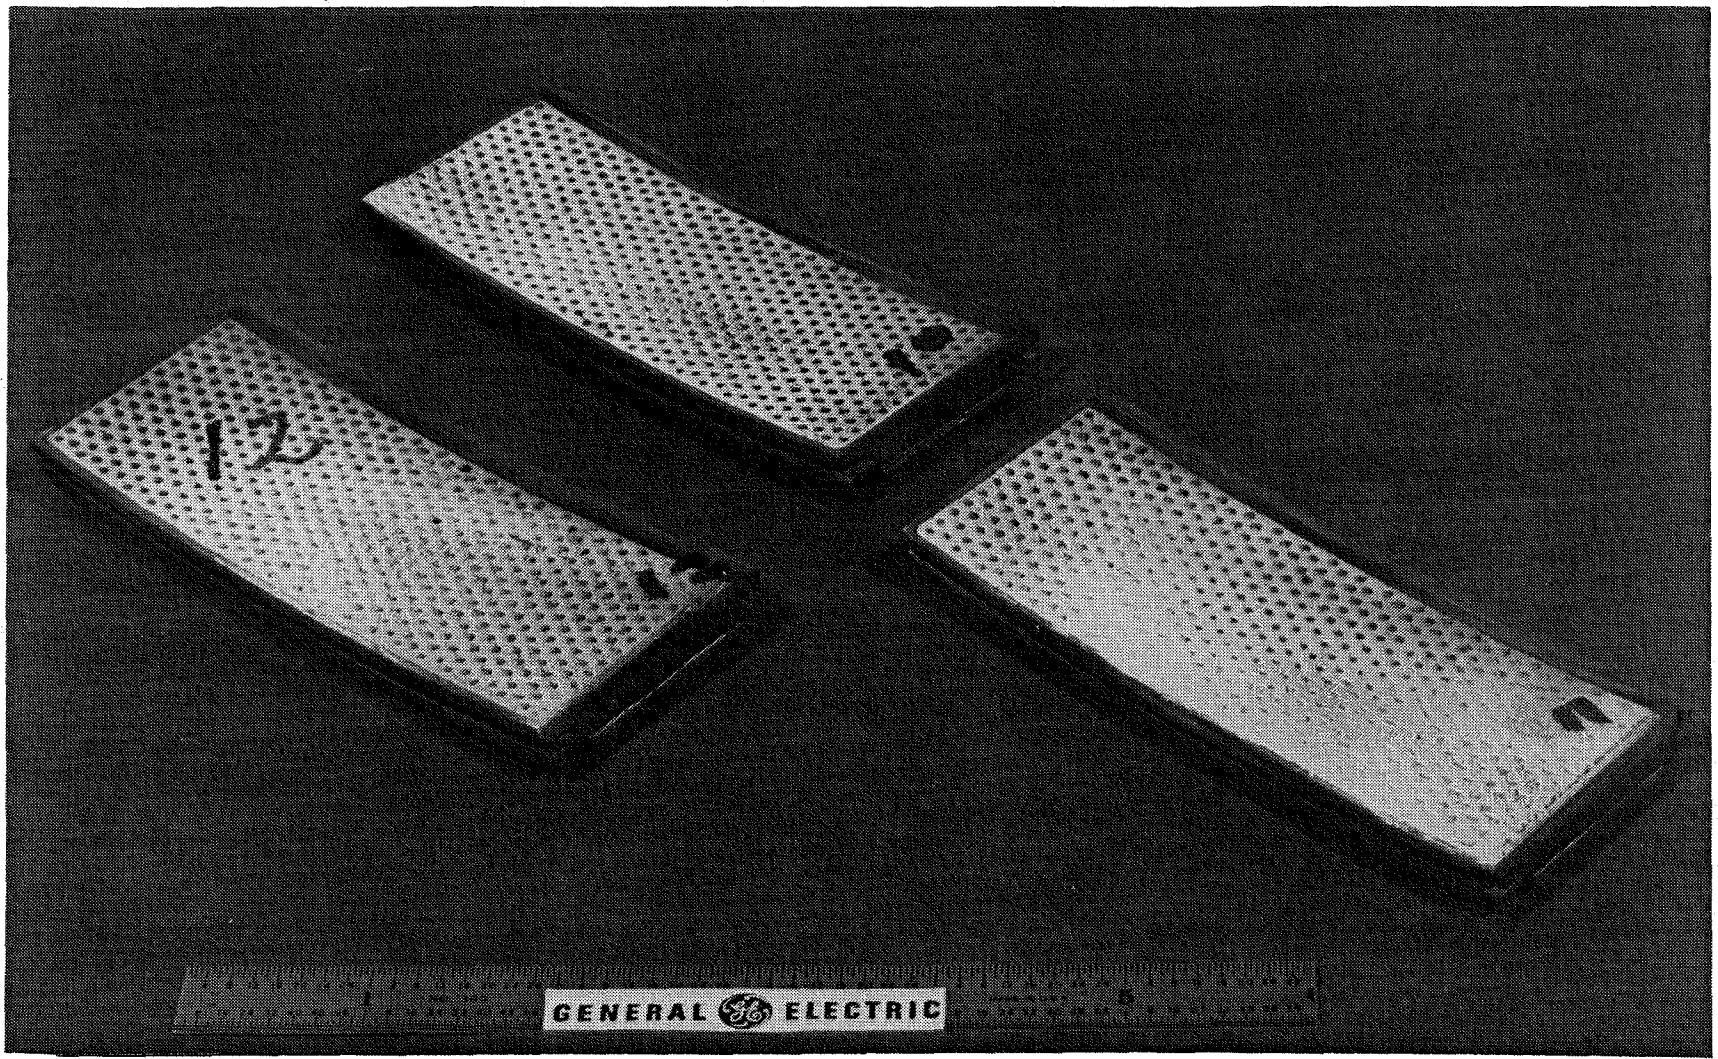
Figure 1. Ceramic Shrouds After Successful CF6-50 Engine Testing

This report describes the work performed on a multi-phased program to develop ceramic High Pressure Turbine (HPT) shrouds for the NASA/GE Energy Efficient Engine (E^3). The program consisted of four phases: 1) selection of a candidate shroud system, 2) development of that shroud system, 3) component testing, including CF6-50 engine testing, static laboratory testing, and development of quality control inspection method using non-destructive techniques, and 4) fabrication of hardware for E^3 engine testing. Examples of successfully tested ceramic shrouds are shown in Figure 1.

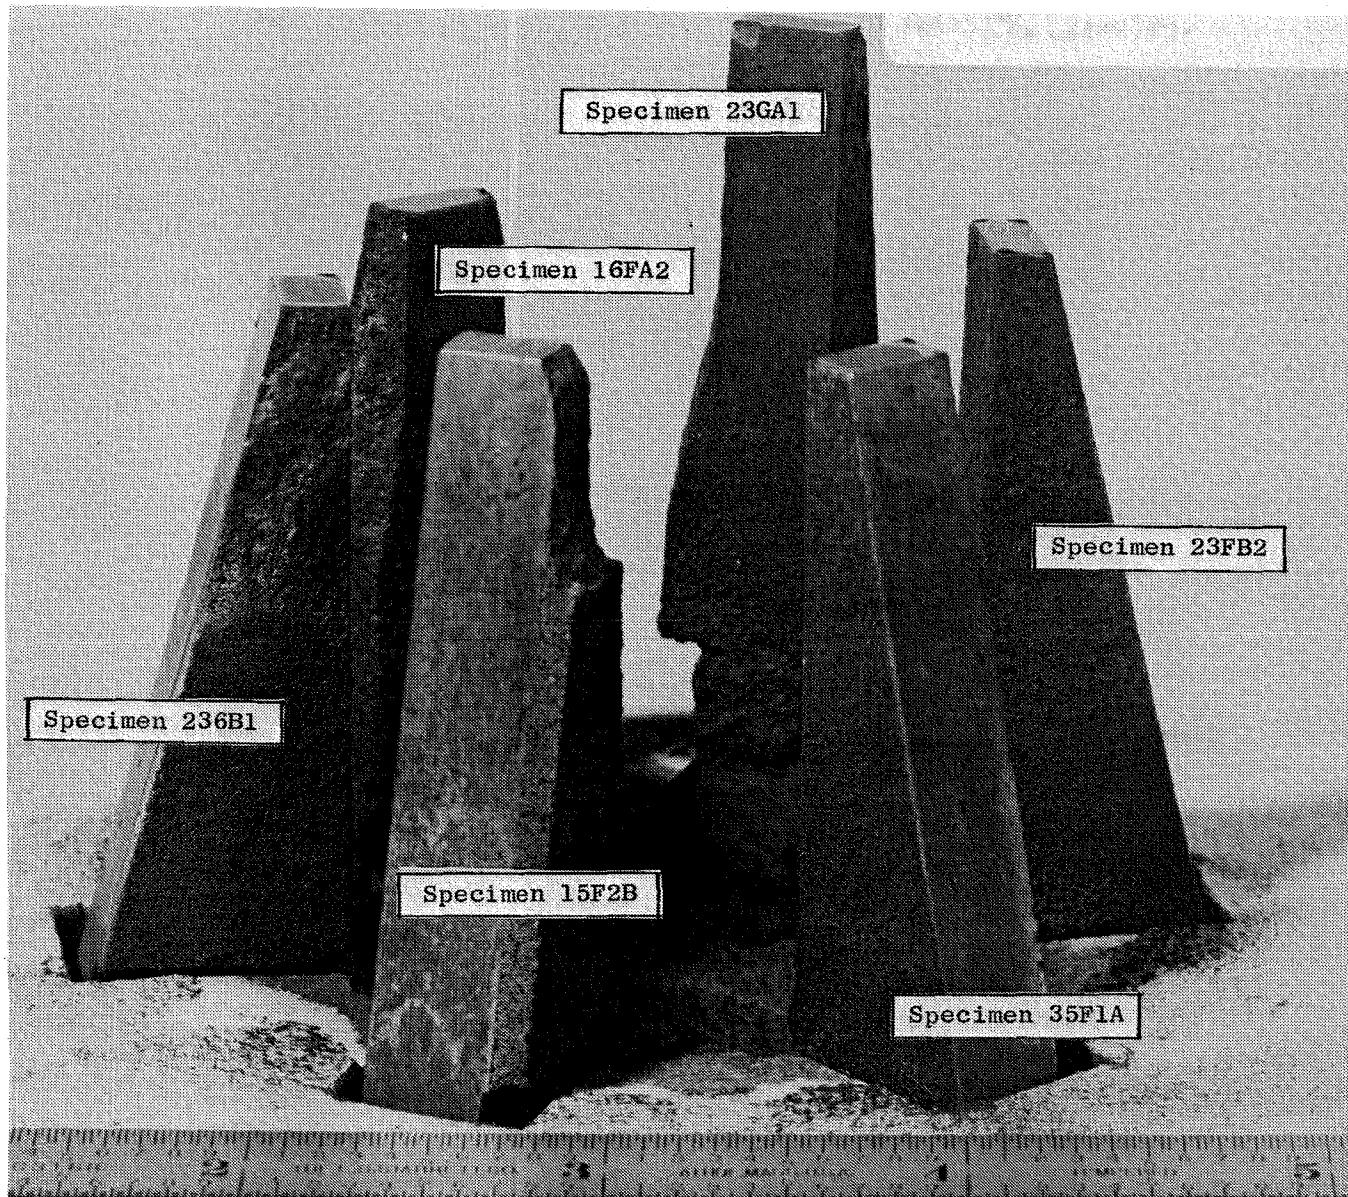
Figure 4. Mach 1.0 Gas Oxidation/Erosion SiC Specimens in Holder After
8 Hours at 1315°C (2400°F) and 20 Hours at 1260°C (2300°F)

In Phase I, two ceramic shroud systems were evaluated in the initial design phase. The two ceramic shroud systems were as follows: 1) zirconia (ZrO_2) plasma sprayed onto structural metal segments and 2) porous boron nitride/silicon carbide/silicon rub layer bonded to solid, hot-pressed silicon carbide which is mechanically held by metal holders. The zirconia shroud system was selected for further developments based on laboratory testing of the two systems. Laboratory evaluations of the two systems consisted of the following: cold particle erosion, hardness, bond strength, metallography, and thermal shock. The SiC ceramic shroud design was dropped from consideration due to inadequate hot gas erosion resistance.

Laboratory testing was conducted to assess pertinent gas-path seal characteristics related to each shroud system. The ZrO_2 and SiC ceramic shrouds were evaluated by metallurgy, hardness, cold particle erosion, tensile bond, and thermal shock testing. Mach 1.0 gas oxidation/erosion on the SiC ceramic along with other pertinent testings were conducted in part, and reported under a separate efforts⁽²⁾. The SiC shroud approach was dropped from consideration due to inadequate hot gas erosion resistance of the boron nitride/silicon carbide/silicon rub layers at expected operation temperatures. Figure 4 shows the severe erosion of the silicon carbide specimens which occurred during hot gas erosion testing at $1315^\circ C$ ($2400^\circ F$) and $1260^\circ C$ ($2300^\circ F$).

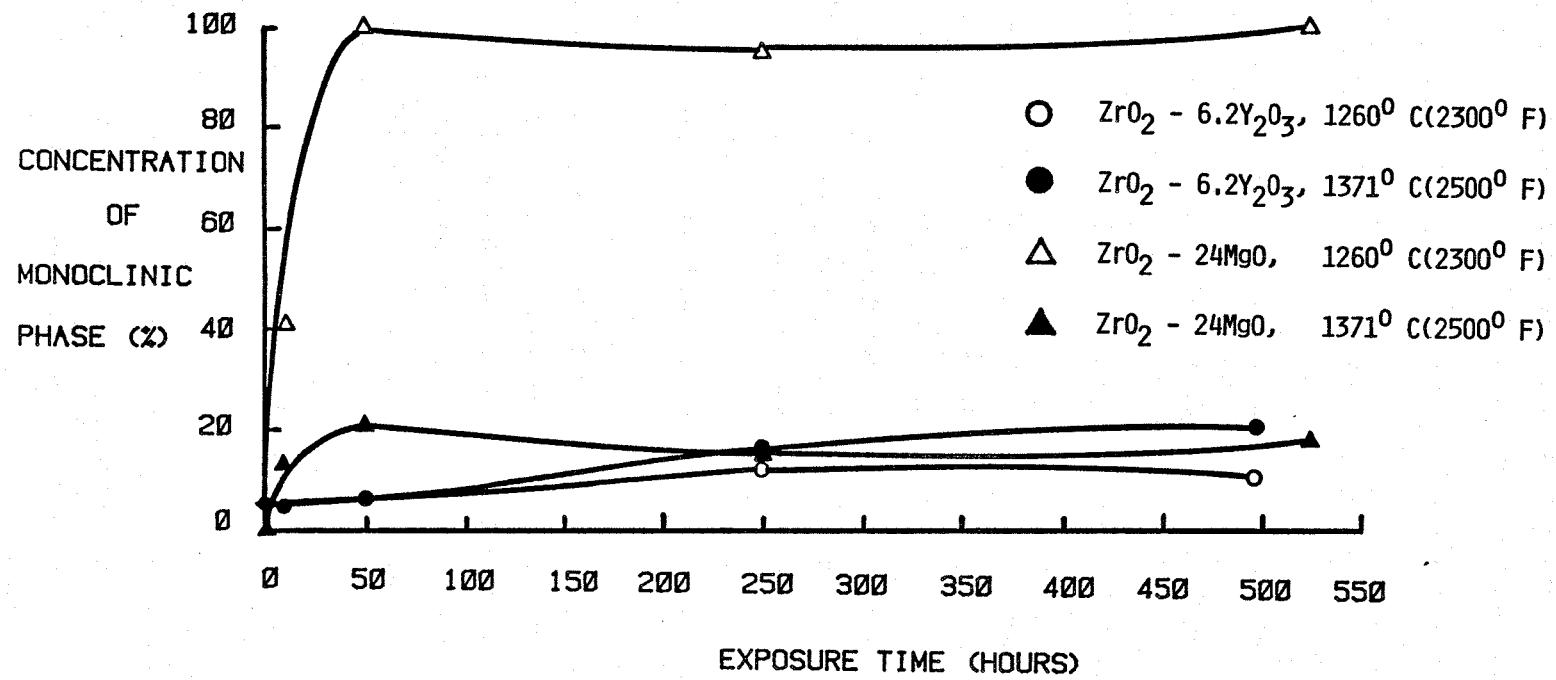
Figure 5. Concentration of Monoclinic Phase vs Exposure Time

Figure 5 shows the percent of monoclinic phase as a function of exposure time. The phase stability study showed that the amount of monoclinic phase in ZrO_2 -6.2 Y_2O_3 increased slightly up to 250 hours of exposure of 1260° C (2300° F) and 1371° C (2500° F), and did not change for exposure up to 500 hours at these temperatures. The ZrO_2 -24MgO became fully monoclinic after only 50 hours at 1260° C (2300° F) and continued to be fully monoclinic for exposures up to 500 hours. At 1371° C (2500° F), the amount of monoclinic phase increased slightly upon exposure but did not further change after 50 hours of exposure.

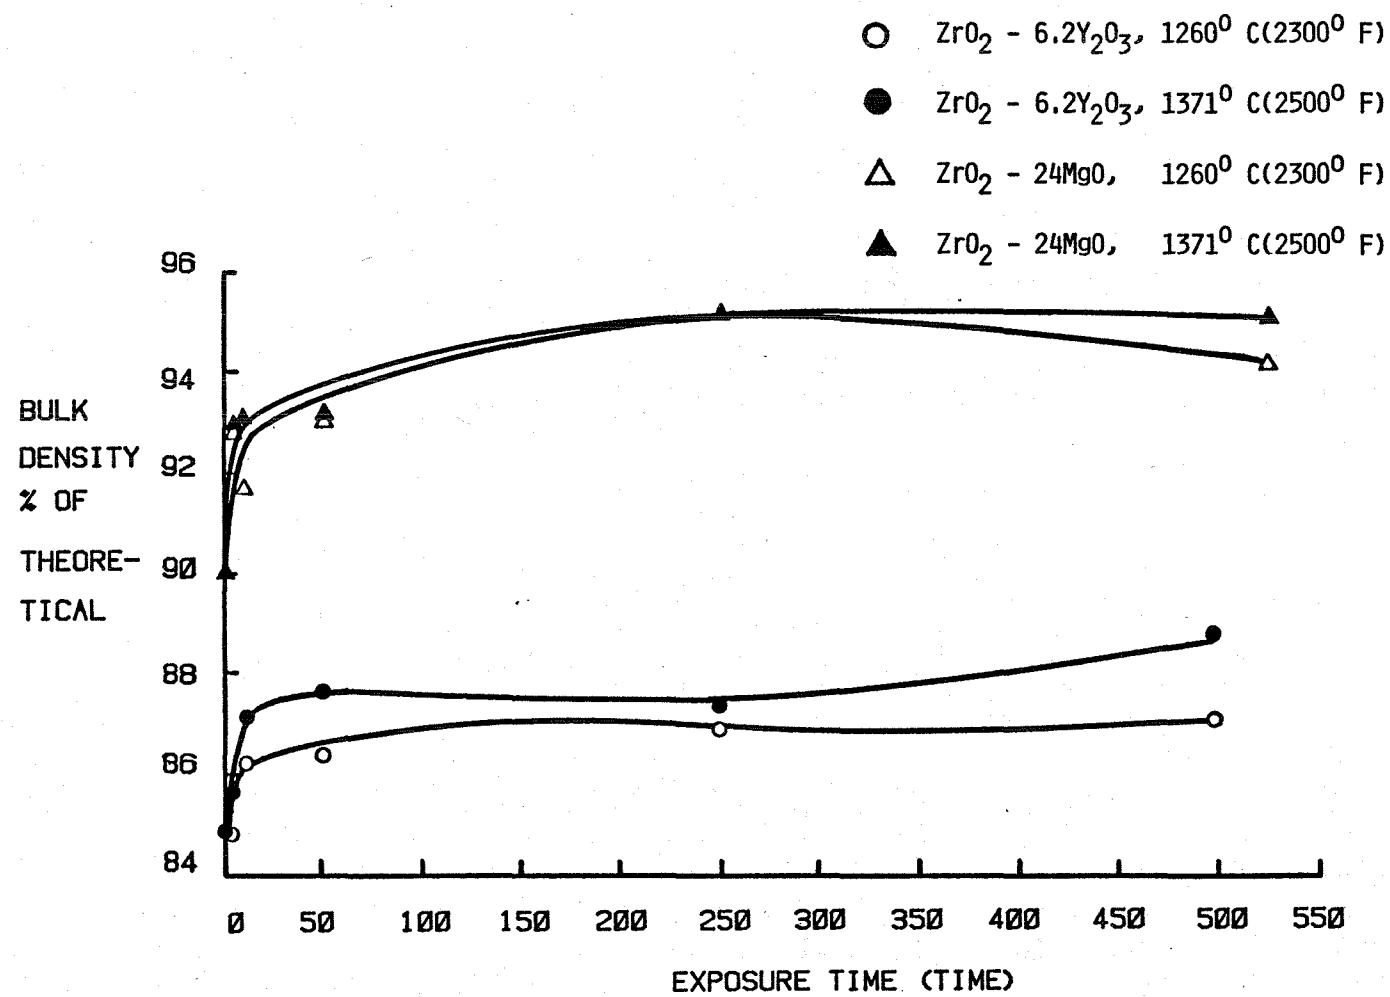
Figure 6. Sintering Behavior

The sintering behavior, of both zirconia chemistries is shown by densification in Figure 6. The as-sprayed density of ZrO_2 -6.2 Y_2O_3 was 5 percent less than that of ZrO_2 -24MgO. After 500 hours of exposure, ZrO_2 -6.2 Y_2O_3 sintered 4 percent at 1371° C (2500° F) and 2 percent at 1260° C (2300° F). The ZrO_2 -24MgO sintered 5 percent at 1371° C (2500° F) and 4 percent at 1260° C (2300° F).

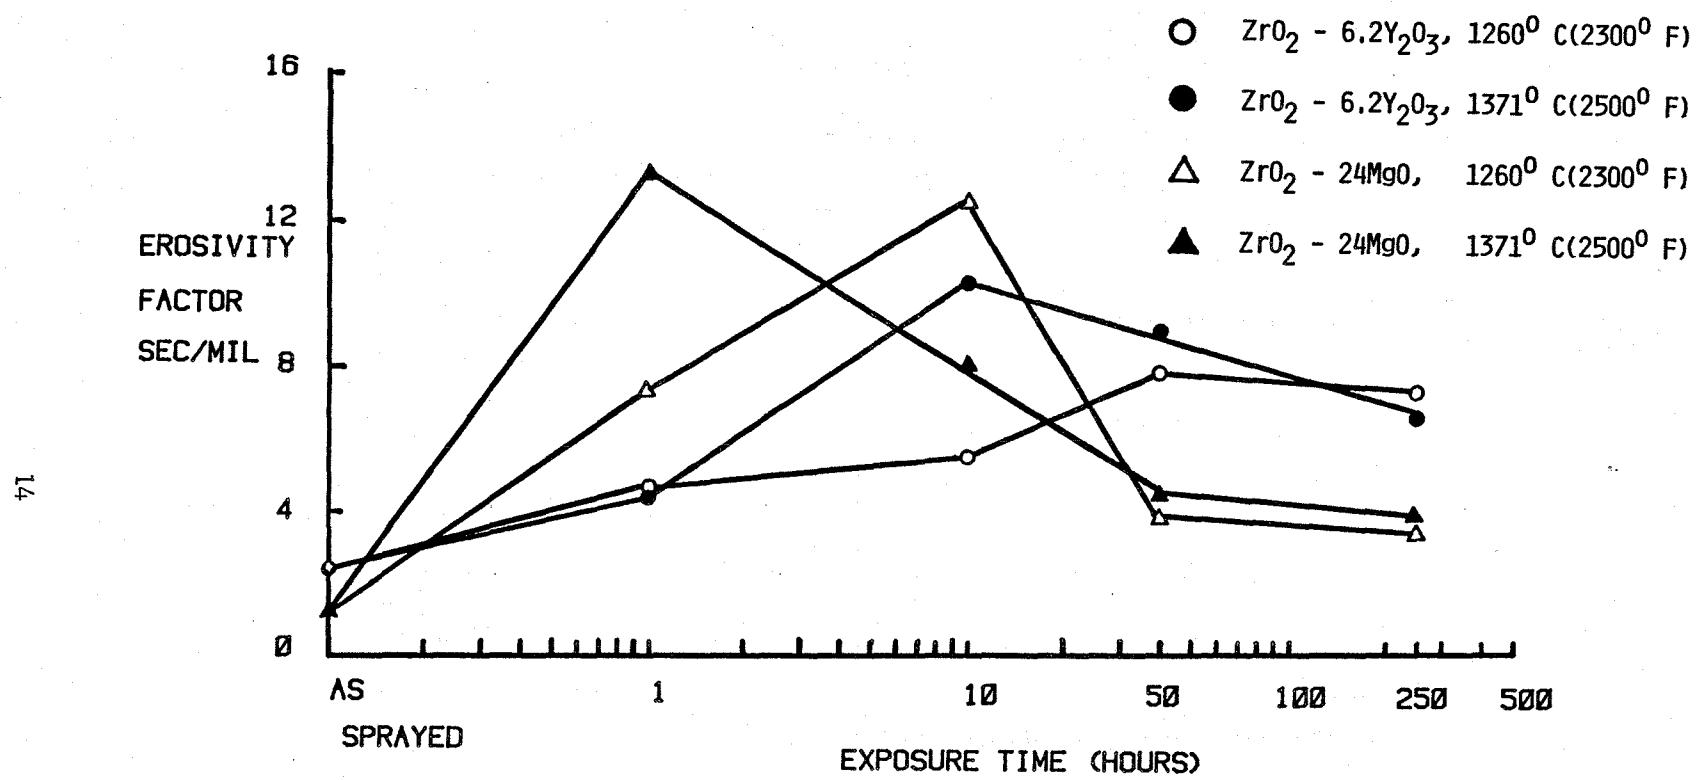
Figure 7. Effect of High Temperature Exposure on Cold Particle Erosion Resistance

Figure 7 is a log-linear plot of cold particle erosion resistance of the two zirconias after high temperature exposure. The erosivity factor is a measure of the rate of erosion of a target material subjected to an alumina grit blast. A high value of erosivity factor [sec/mm(sec/mil)] denotes good cold particle erosion resistance. The test data indicates that ZrO_2 -6.2 Y_2O_3 after exposure time of greater than 10 hours has better cold particle erosion resistance than ZrO_2 -24MgO.

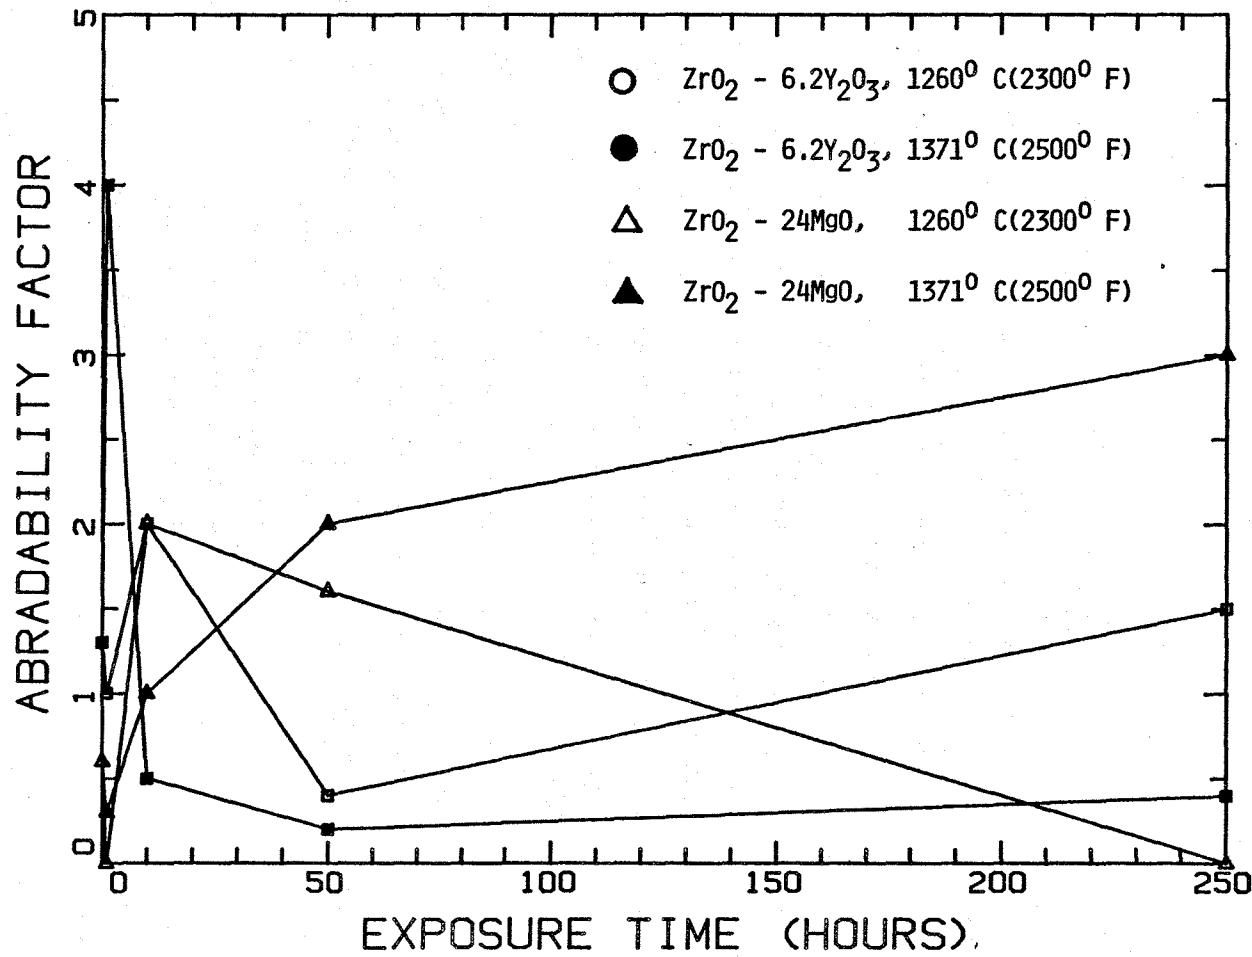
Figure 8. Effect of High Temperature on Abrasion Resistance

Figure 8 presents a log-linear plot of the room temperature abradability behavior as a function of exposure time. In abradability testing, the abradable material is supported on a platform beneath the rotating blade elements. During the test, the blades rotate at 229 sms (750 sfs) with an incursion rate of 0.025 mm/second (1 mil/second) to generate a total incursion of about 0.508 mm (20 mils). The abradability factor is a measure of rub behavior and is given by the equation below:

Higher values of abradability factor indicate better room temperature rub behavior, i.e., less blade wear. One shortcoming of this formula is the unaccountability for any blade metal transfer to the coating surface during rub (scabbing). No clear trends could be established from the data in Figure 8 due to scabbing and blade distress which occurred. The abradability of zirconia coatings seems to decrease after 250 hours exposure, most probably due to densification of the coating. For both chemistries, the specimens could not be rubbed for more than 5 seconds [incursion rate of 0.0254 mm (0.001 inch/second)] due to scabbing and blade distress. In conclusion, the type of ZrO₂ (MgO, Y₂O₃) used was not shown to be a significant variable in wear chemistries.

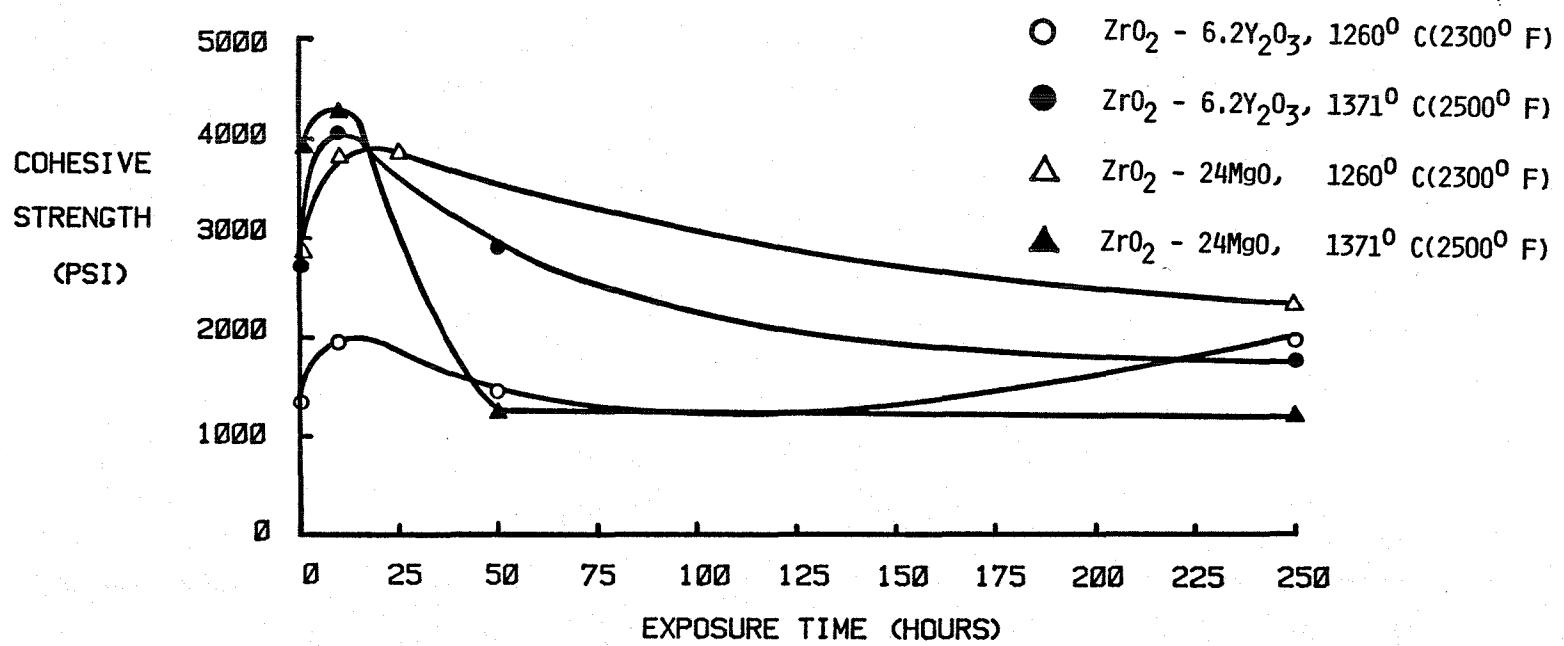
Figure 9. Effect of High Temperature Exposure on Cohesive Strength

Room temperature tensile bond testing to determine cohesive strength was conducted on 2.54 cm (1 inch) diameter discs. Tensile tab segments of 2.54 cm (1 inch) were bonded to the ceramic surface and the substrate and pulled to failure at 0.127 mm/min (0.005 inch/min). The change in cohesive strength versus exposure time is shown in Figure 9. In general, these results show that the cohesive bond strength decreases with exposure time. The effect of exposure times on hardness was also determined. The hardness scale was selected as R15Y which was a 1.27 cm/min (0.5 inch) diameter steel ball indenter and a load of 15 kg (33 lbs). Figure 10 shows that the two zirconias have similar room temperature surface hardness.

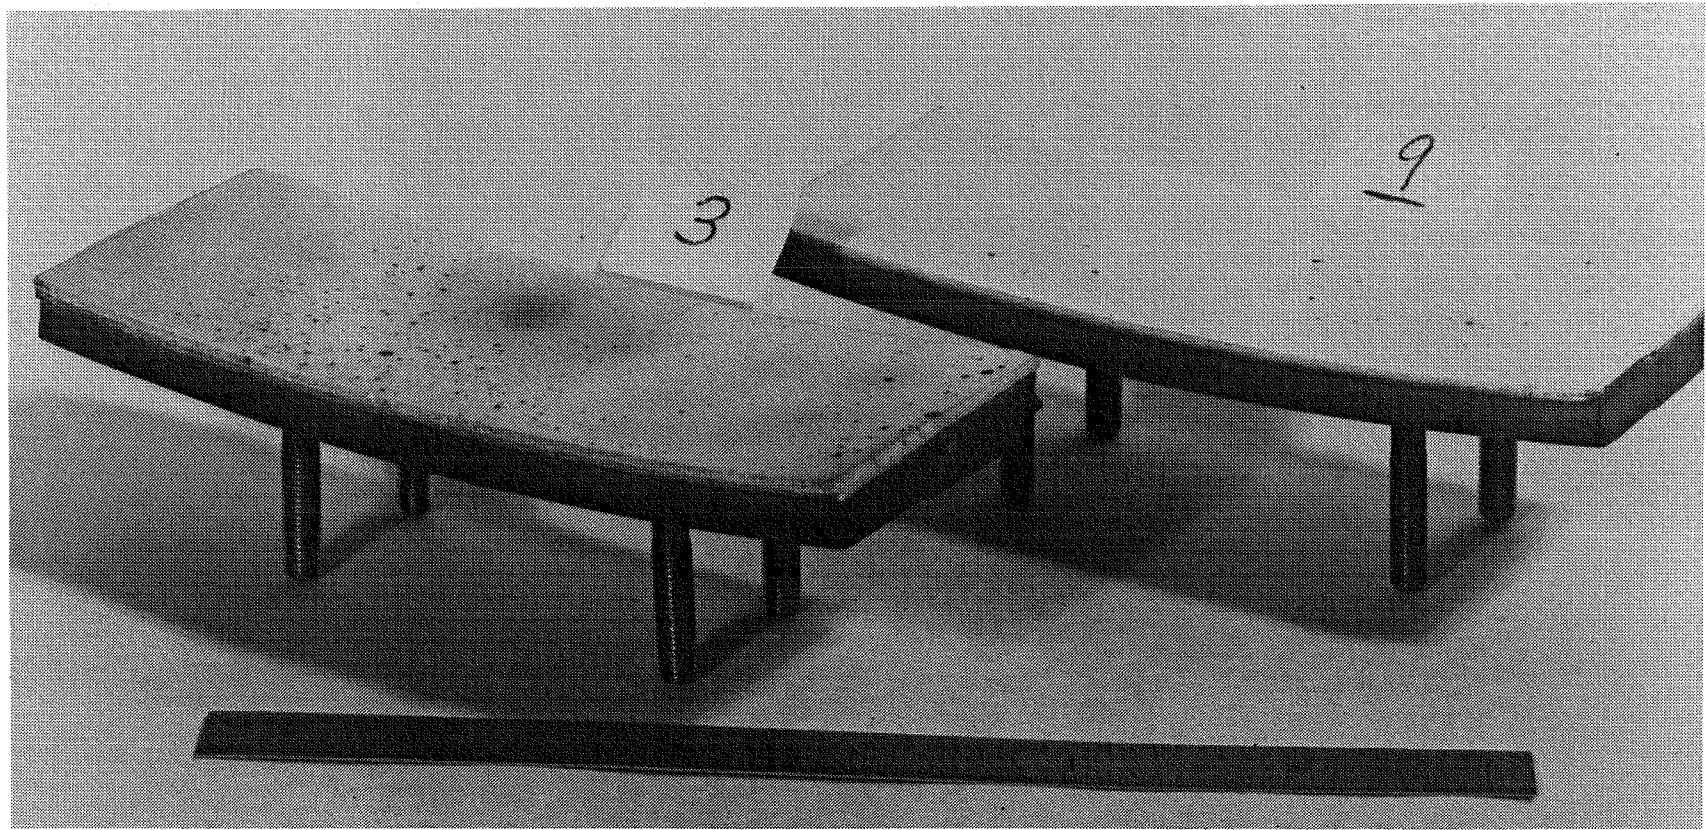
Figure 12. Ceramic Shroud Segments after 500 Test Cycles

for 50, 200, 500, and 1000 cycles. The thermal shock tests apparatus is pictured in Figure 11. Separate shroud segments were used for 50, 200, and 500 cycles. Figure 12 shows the shrouds after 500 cycles. The 500-cycle specimens were then tested for an additional 500 cycles to accumulate 1000 cycles. The Zr₂-6.2Y₂O₃ specimens cycled for 50, 500, and 1000 cycles contained no mud flat surface cracking, no cracks along the edges, but did have some corner and edge clipping (probably related to ZrO₂ overspray). The ZrO₂-24MgO specimens cycled for 50, 500, and 1000 cycles did show mud flat surface cracking as well as an edge crack along the perimeter of the specimen at the ZrO₂-24MgO bond interface which grew wider with increased number of cycles. No separation of the ZrO₂-24MgO took place, however. On the other hand, the ZrO₂-6.2Y₂O₃ specimen which cycled for 200 cycles showed some mud flat surface cracking and edge cracking, while the 200-cycle ZrO₂-24MgO specimen contained no mud flat cracking although it did contain some edge cracking. This lower than expected thermal shock behavior after 200 cycles for the ZrO₂-6.2Y₂O₃ specimen was anomalous to what had occurred previously. A repeat of this experiment using additional shrouds showed ZrO₂-6.2Y₂O₃ shrouds to be superior to ZrO₂-24MgO.

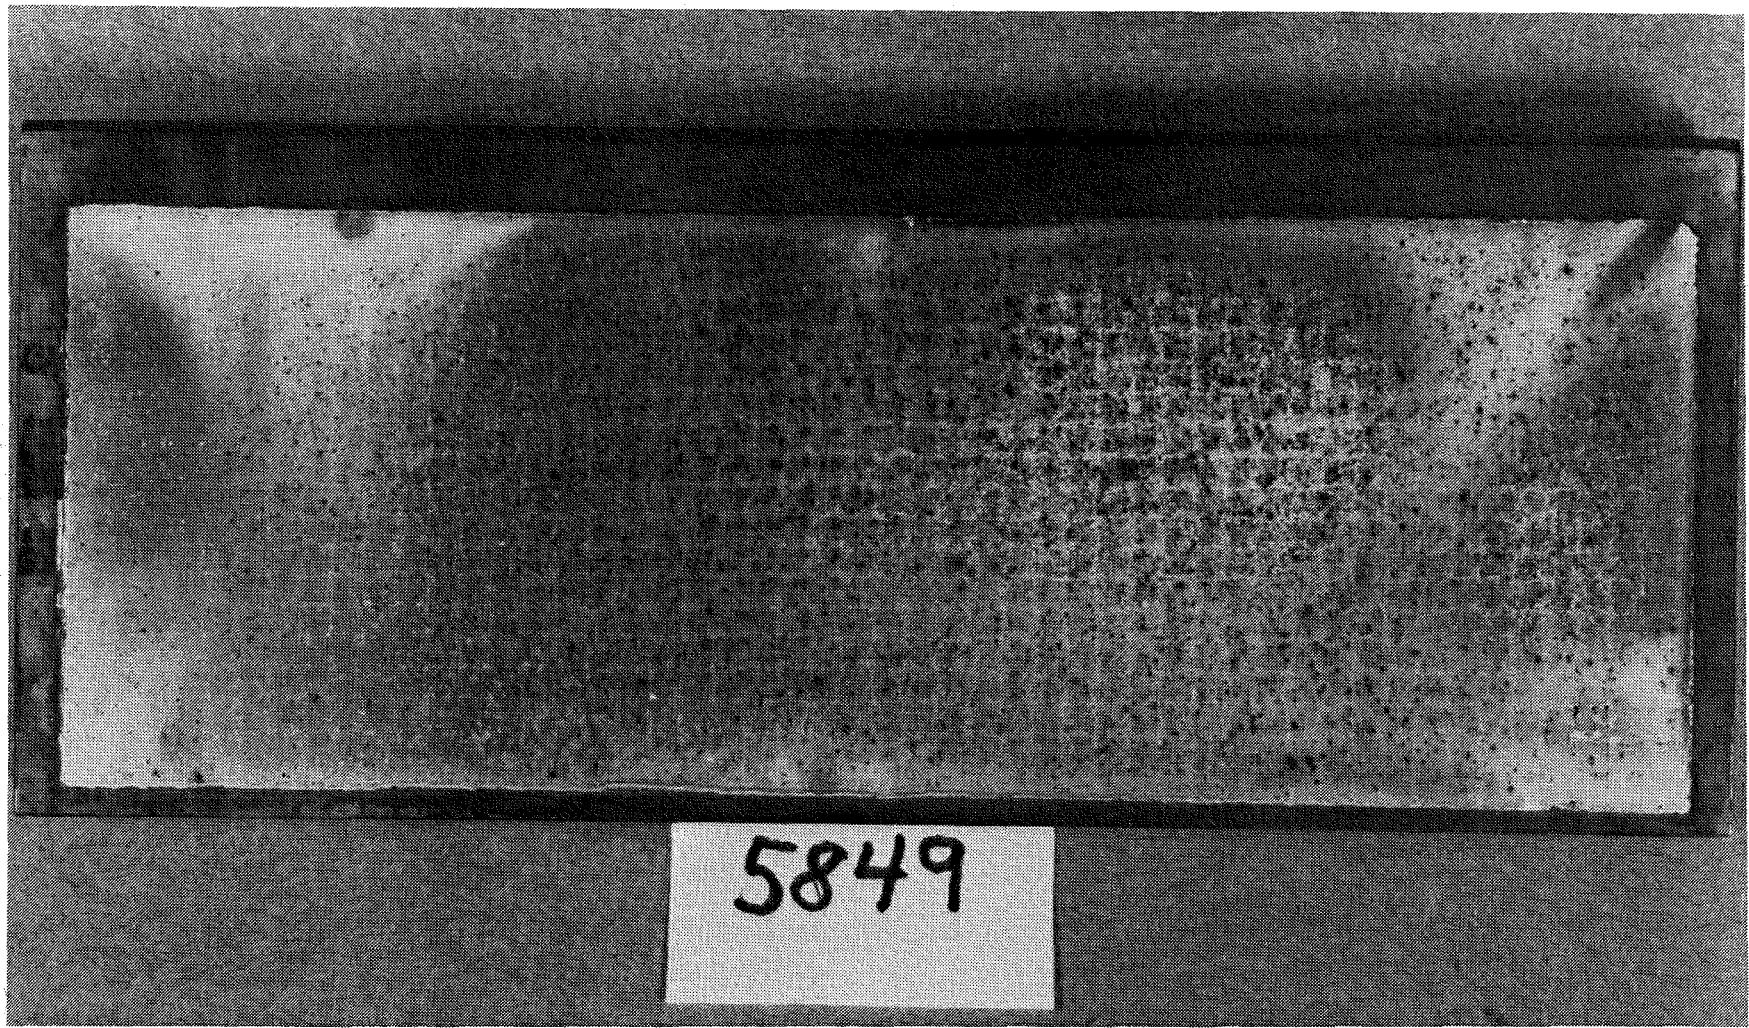
Figure 14. $\text{ZrO}_2 - 6.2\text{Y}_2\text{O}_3$ Coated Wire Mesh Shroud

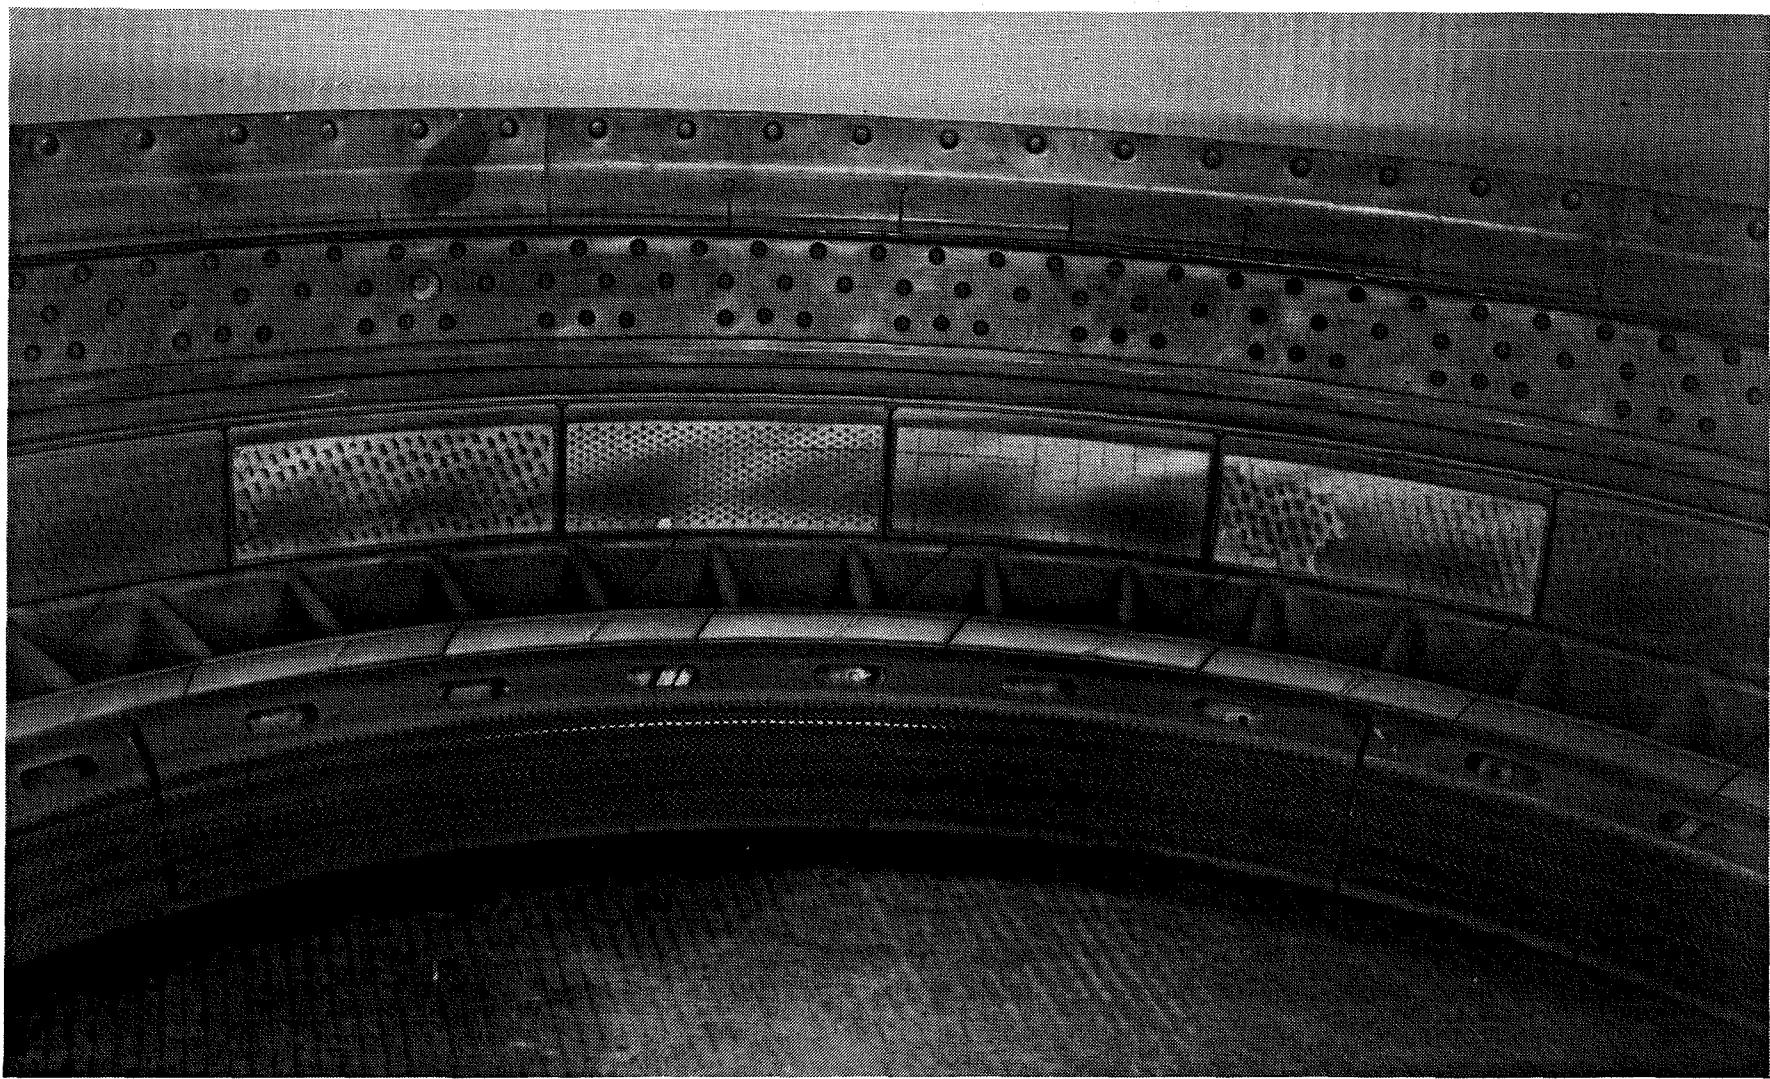
Figure 16. Four Shrouds With Different Design Configurations After
0.7 Hours CF6-50 Engine Testing

5.07 hours at the turbine rotor inlet temperature in the range of 1371° C (2500° F) to 1400° C (2550° F) (maximum). Figure 16 shows the four different shroud configurations after engine testing. The wire mesh shrouds showed no distress, while the superpeg shrouds exhibited minor spalling of zirconia top coat at the edges which did not have a full row of pegs. One shroud from both the remaining designs of the standard support peg array and of the half-height buried peg array, showed unacceptable spallation of the zirconia top coat. The wire mesh and superpeg designs were deemed best of those tested and both were selected for further development and evaluation.

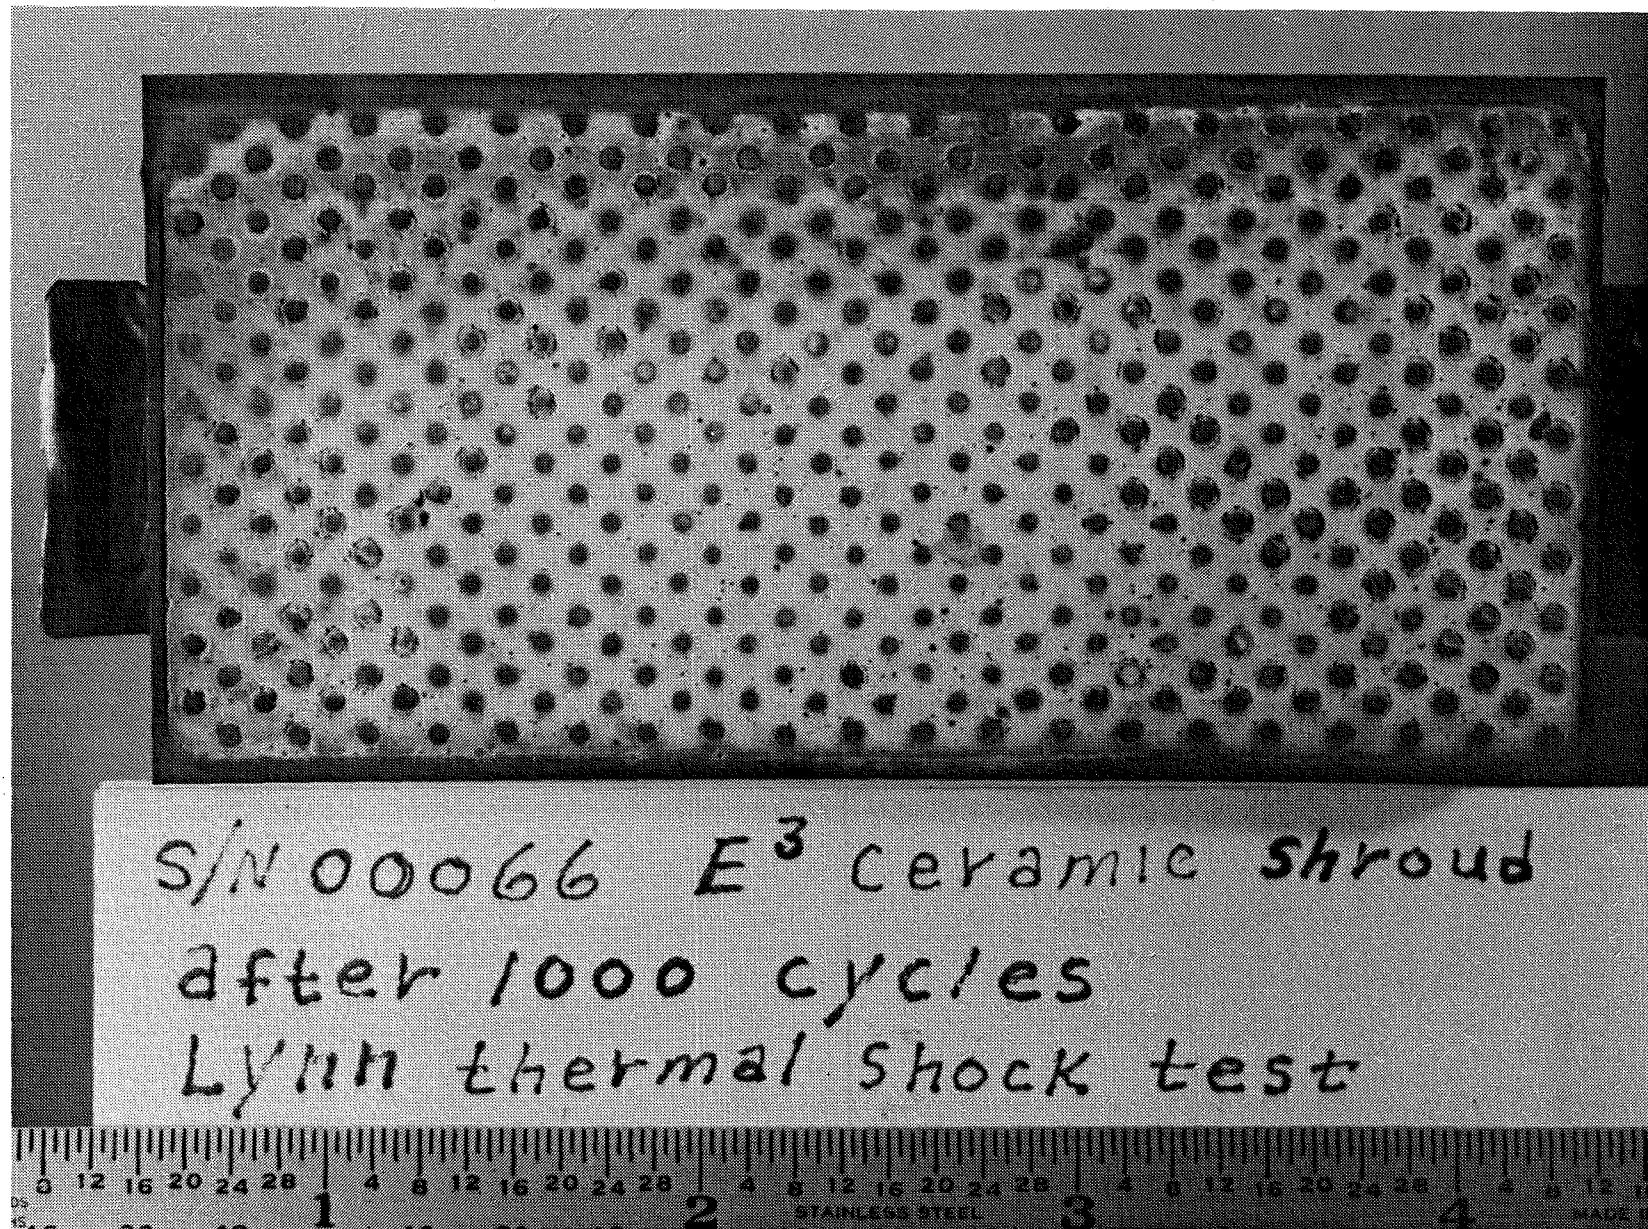
Figure 21. E³ Ceramic Shroud after 1000 Thermal Shock Cycles

Two ceramic shrouds from Lot 1 were successfully subjected to 1000 cycles in the Lynn thermal shock test. Post-test infrared NDE inspection revealed no defects and this was confirmed by microscopic examination of one shroud. The thermal shock test was conducted at 1400° C (2500° F) flowpath surface and 793° C (1460° F) backside temperature, followed by forced air cooling to less than 204° C (400° F). Each cycle consisted of three minutes heating to temperature and three minutes cooling. Figures 21 and 22 show the two shrouds after completion of 1000 thermal shock cycles. Discoloration of the coating in the central region was determined, via scanning electron microscopy and EDAX, to be copper contamination from the heating torch. Even under such severe testing conditions no coating spallation occurred, attesting to the excellent thermal shock capability of this ceramic shroud system.

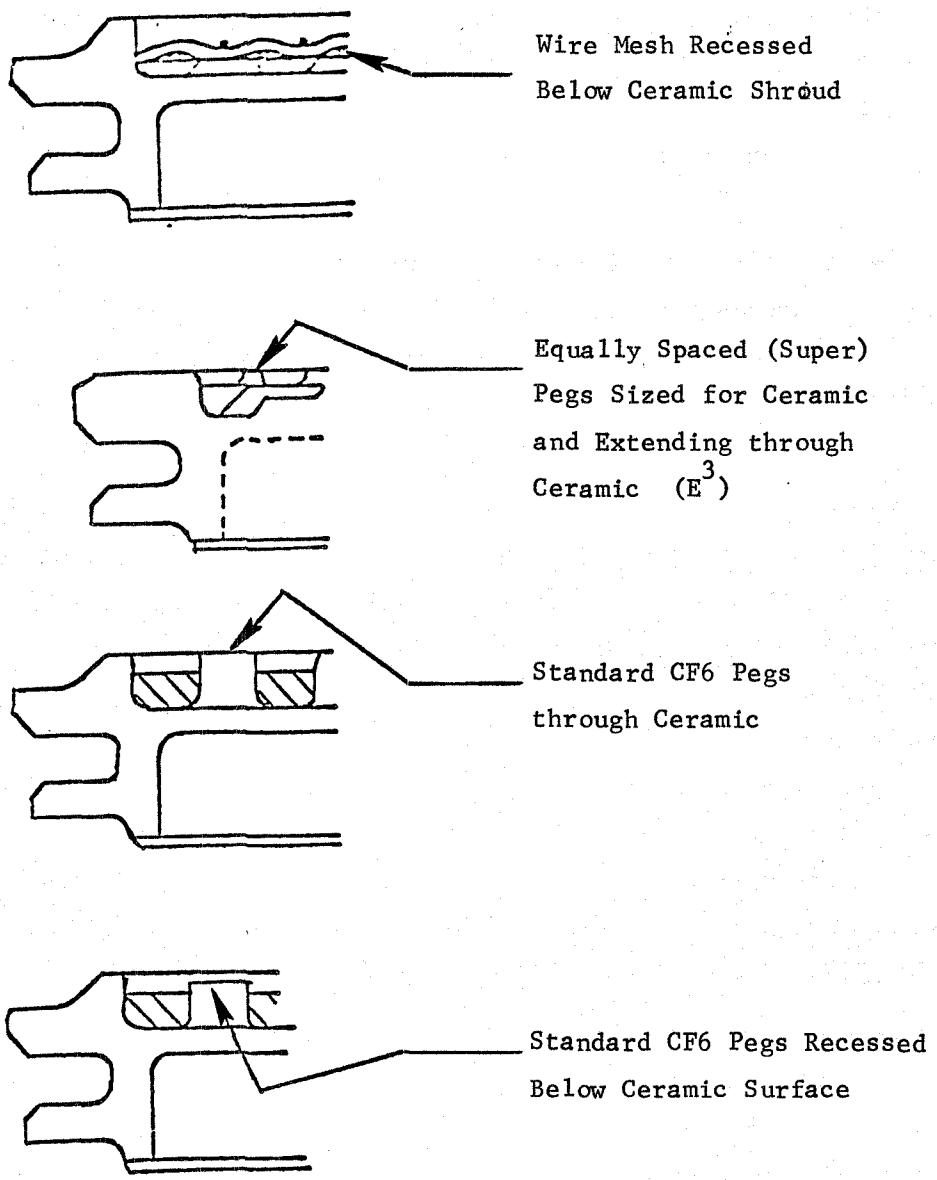
In the CF6-50 peg design arrangement, the ceramic was sprayed, covering the peg to protect it from exposure to the hot gases in one configuration, and also in a configuration whereby the pegs were exposed to the hot gases. Figure A-1 shows a schematic crosssection of the four different bonding techniques used during the development phase.

Figure A-1 Engine Test Ceramic Shrouds Characteristics

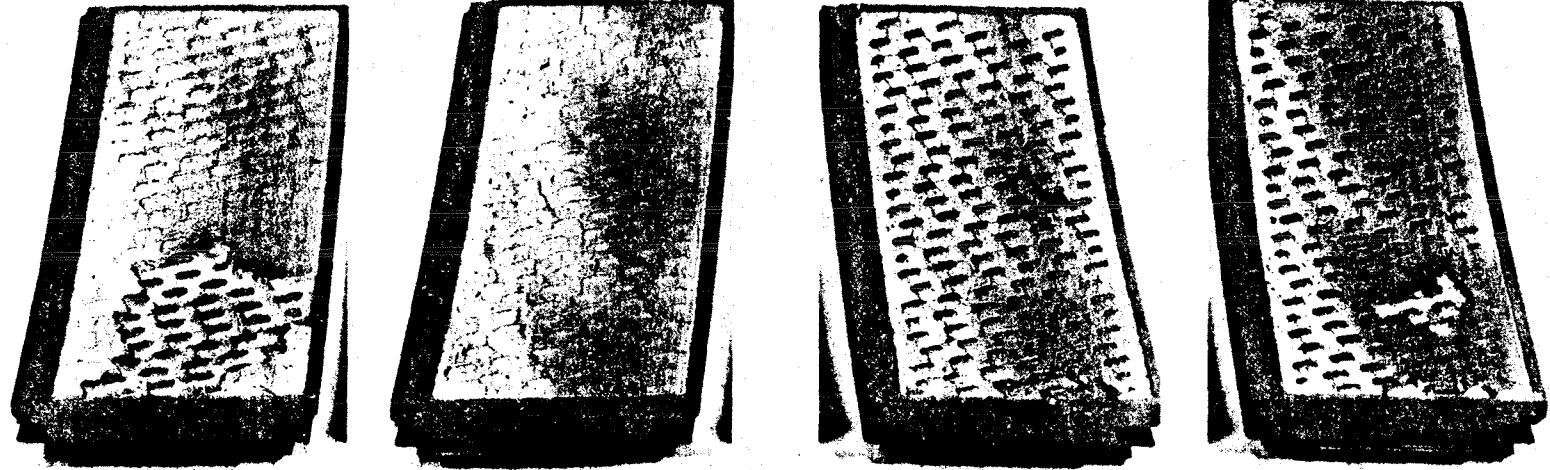
Figure A-2. Zirconia Oxide Shrouds, CF6-50 Engine - 1979 Test

shown in Figures A-2 and A-3. Condition and evaluation of the shrouds after testing showed the wire mesh configuration to contain considerable more surface cracks than the superpeg. The E³ design superpeg shrouds shown in Figure A-2 were observed to be in very good condition. The shrouds with the CF6-50 peg design had experienced various degrees of spallation as shown in Figure A-3.

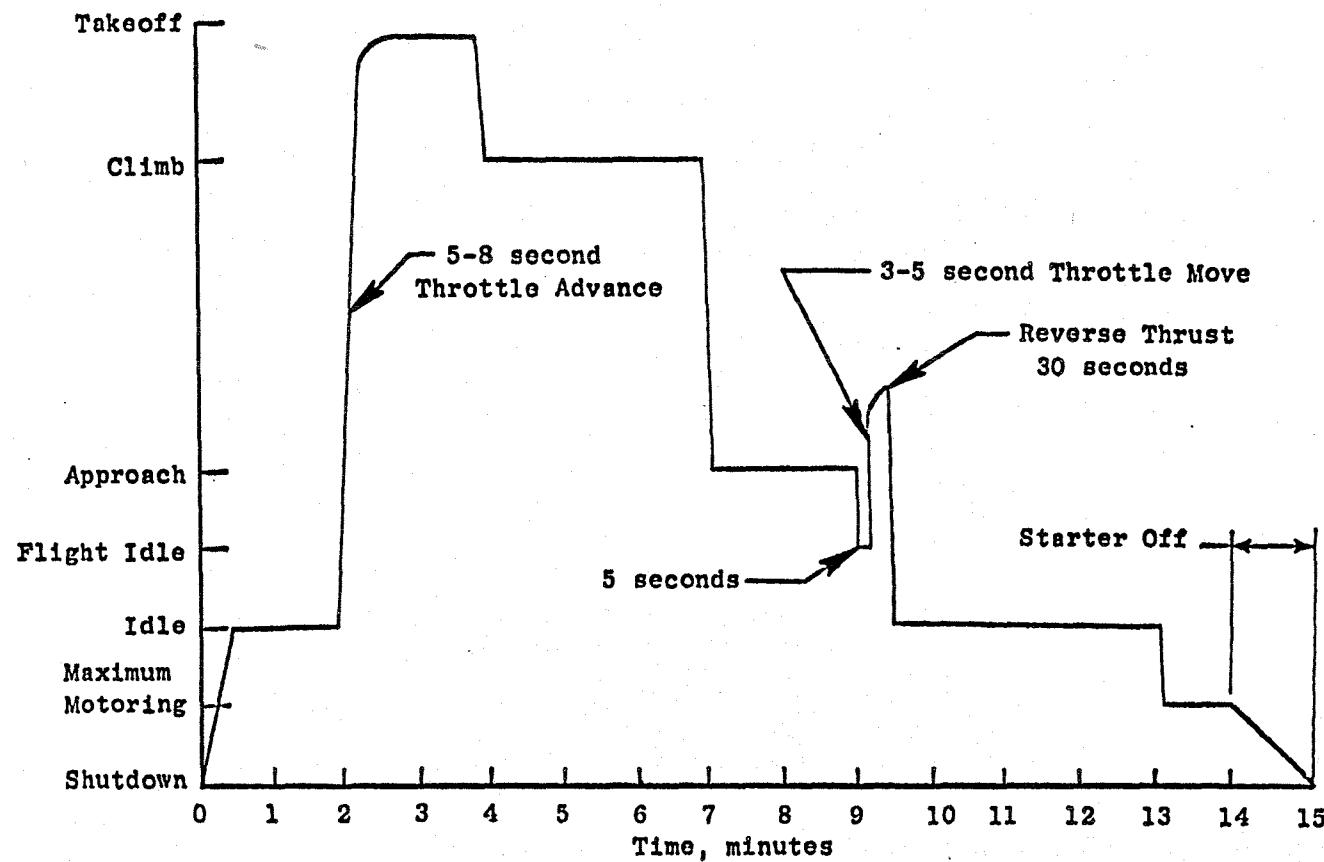
Figure A-4. CF6-50 Engine Endurance Test "C" Cycle

Visual examination showed that the four superpeg shrouds had no spalling and are in good condition for continued engine testing. The wire mesh ceramic shrouds had significant loss of the ceramic face material, some in the top coat and some down into the mesh. Further testing is planned in a CF6-50 engine for 1000 "C" cycles using two of the superpeg shrouds which were tested for 750 "C" cycles.
